Cultural Resources Technical Report

Multnomah County | Earthquake Ready
Burnside Bridge Project

Earthquake Ready Burnside Bridge Cultural Resources Technical Report

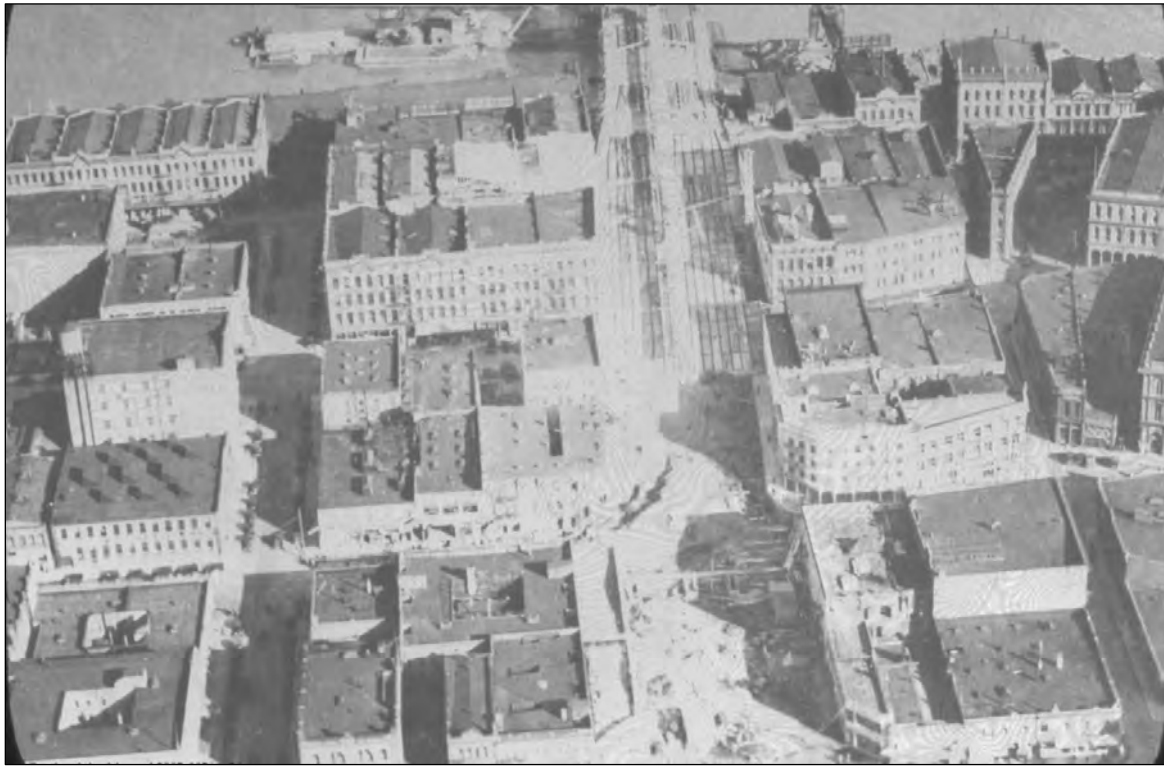
Figure 5-8. Aerial view of construction of the western approach to the new Burnside Bridge in 1926, showing loss of frontages for buildings on W. Burnside east of NW/SW 2nd Avenue and buildings along Front Street before construction of the Harbor Wall.

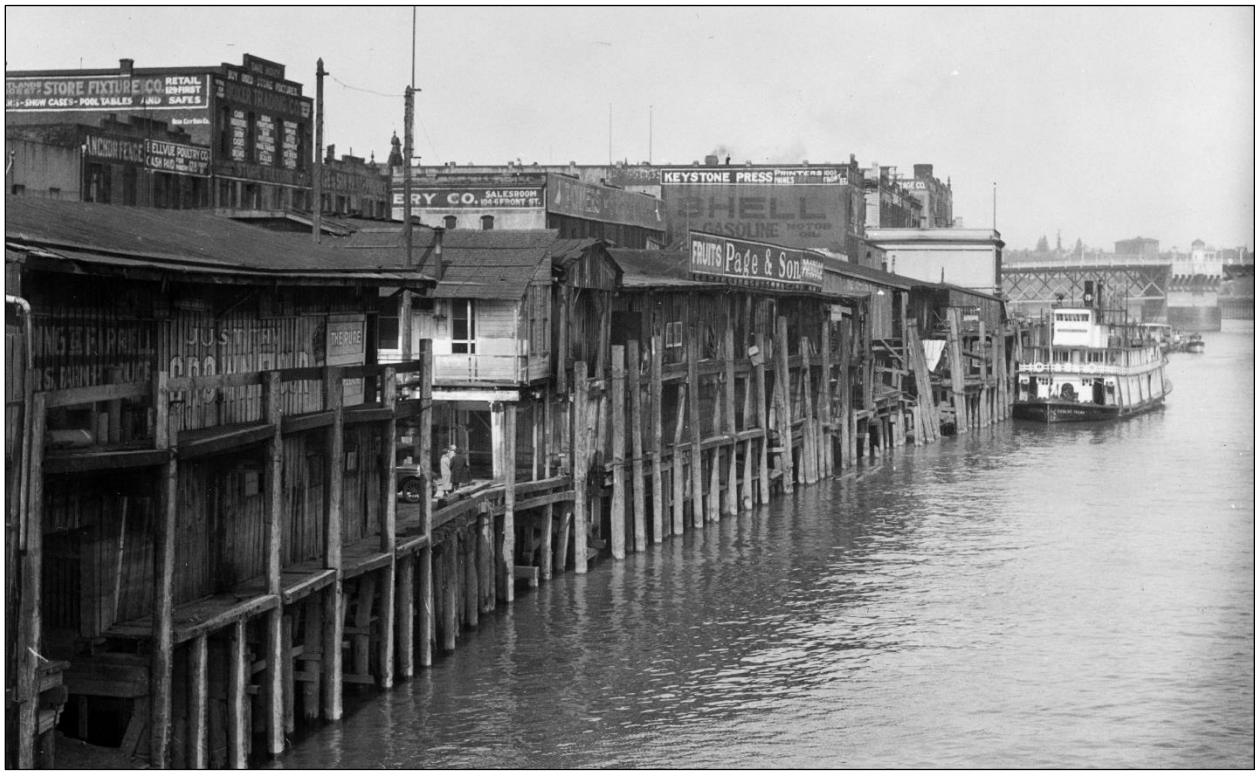
Figure 5-22. Docks and wharves along the west bank showing poor conditions of these structures, looking downriver to the current Burnside Bridge. The photo dates between 1926 and 1929.

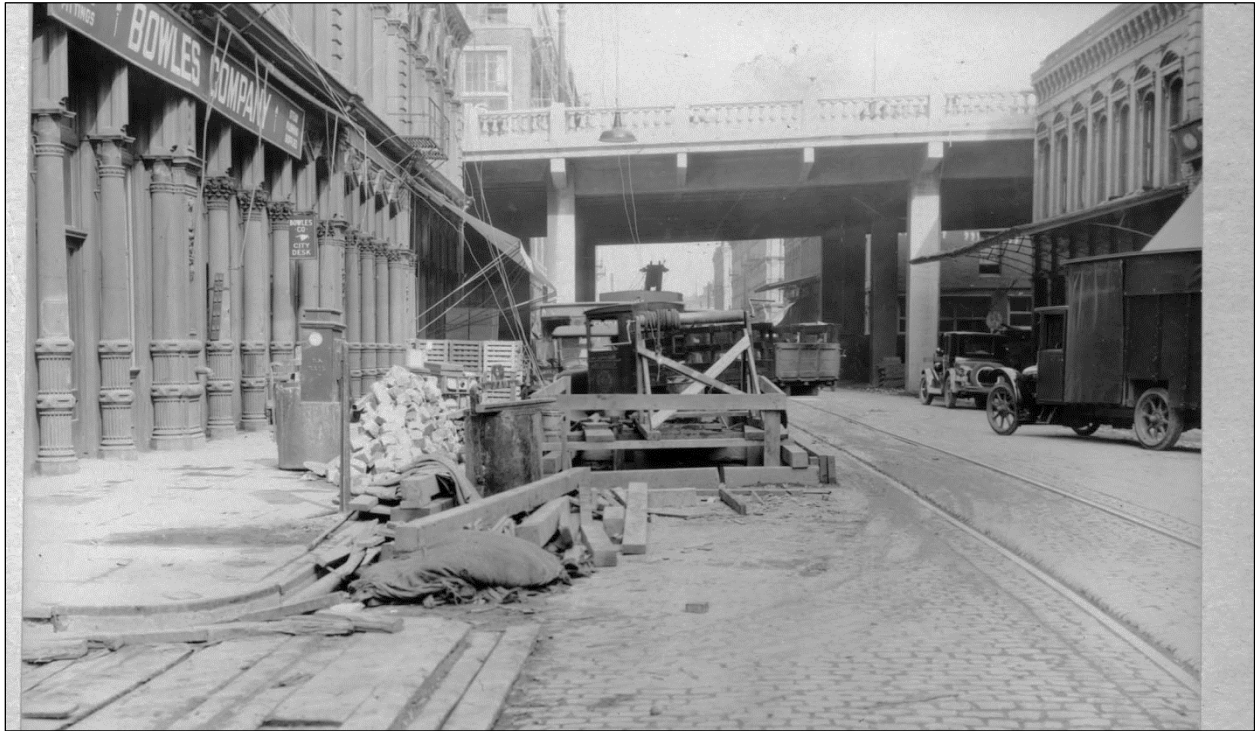
Figure 5-24. Open trench construction of the Front Street intercepting sewer along Front Street, looking north to the Burnside Bridge approach. Photo dated 1928.

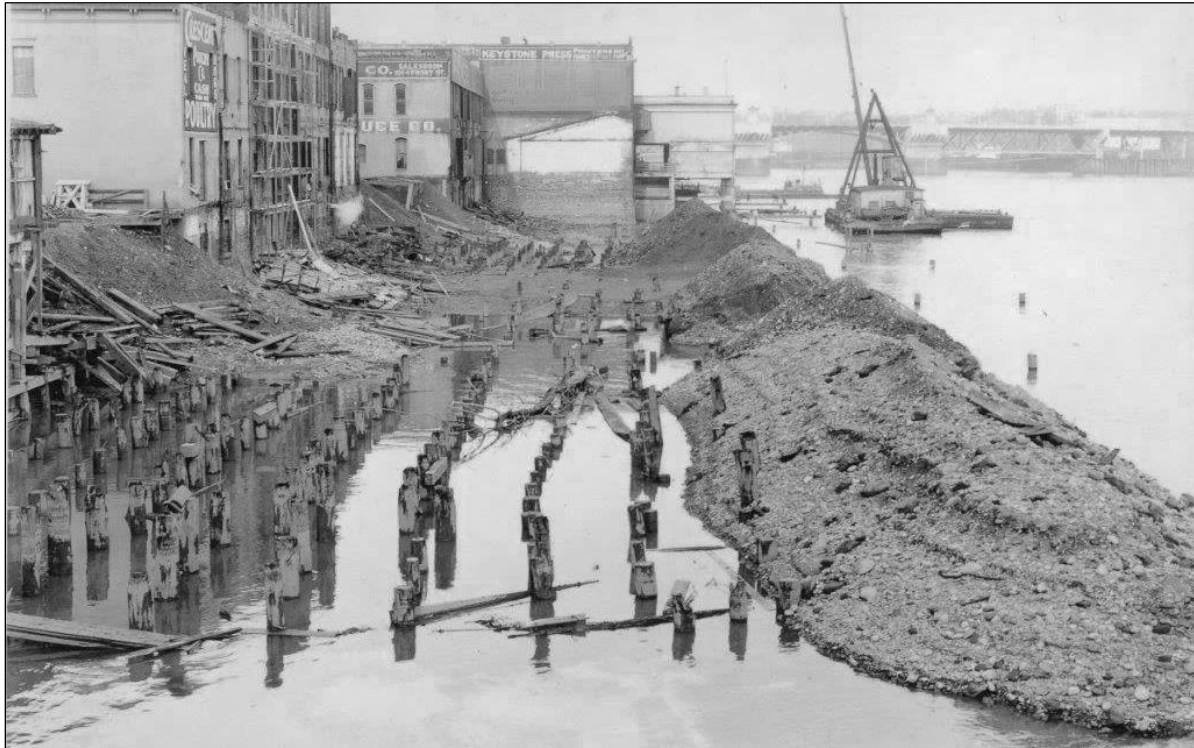
Figure 5-30. Remnant piling from demolished docks as Harbor Wall construction begins, looking downriver to the Burnside Bridge. Photo dated January 28, 1928.

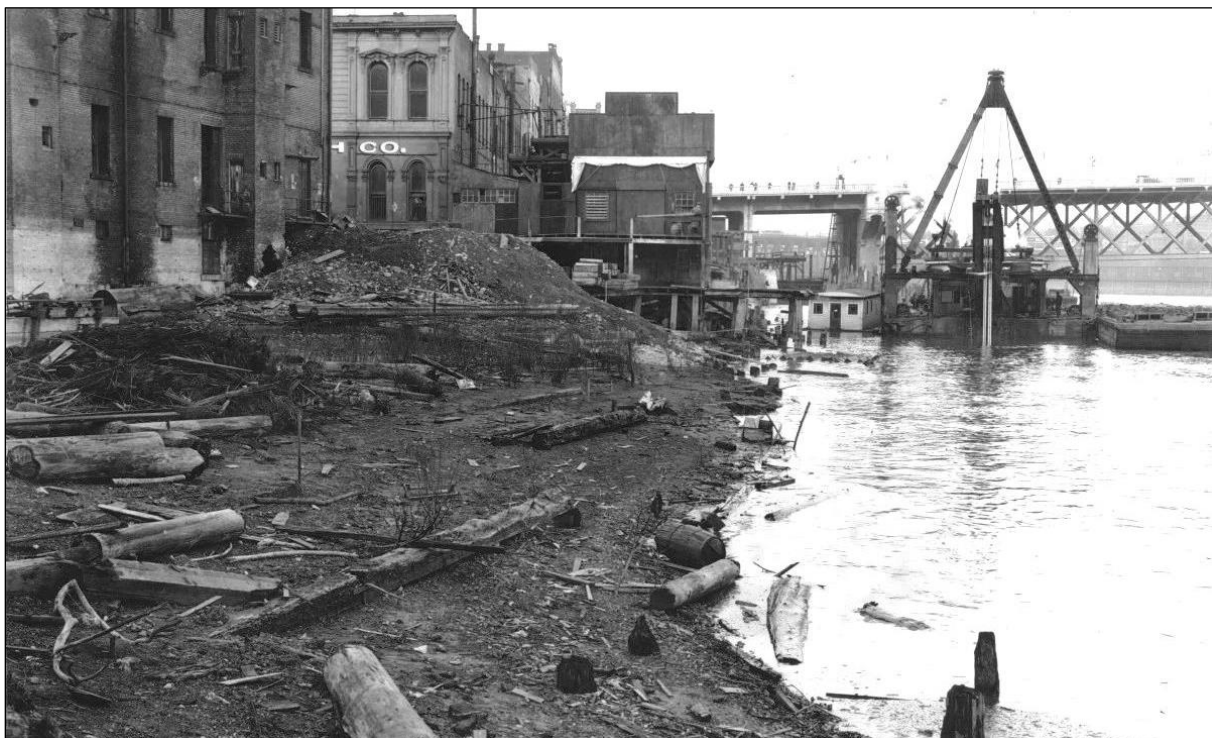
Figure 5-31. Clearance of docks and wharves in preparation of construction of the Harbor Wall, with the Burnside Bridge to the north. Photo dated January 31, 1928.

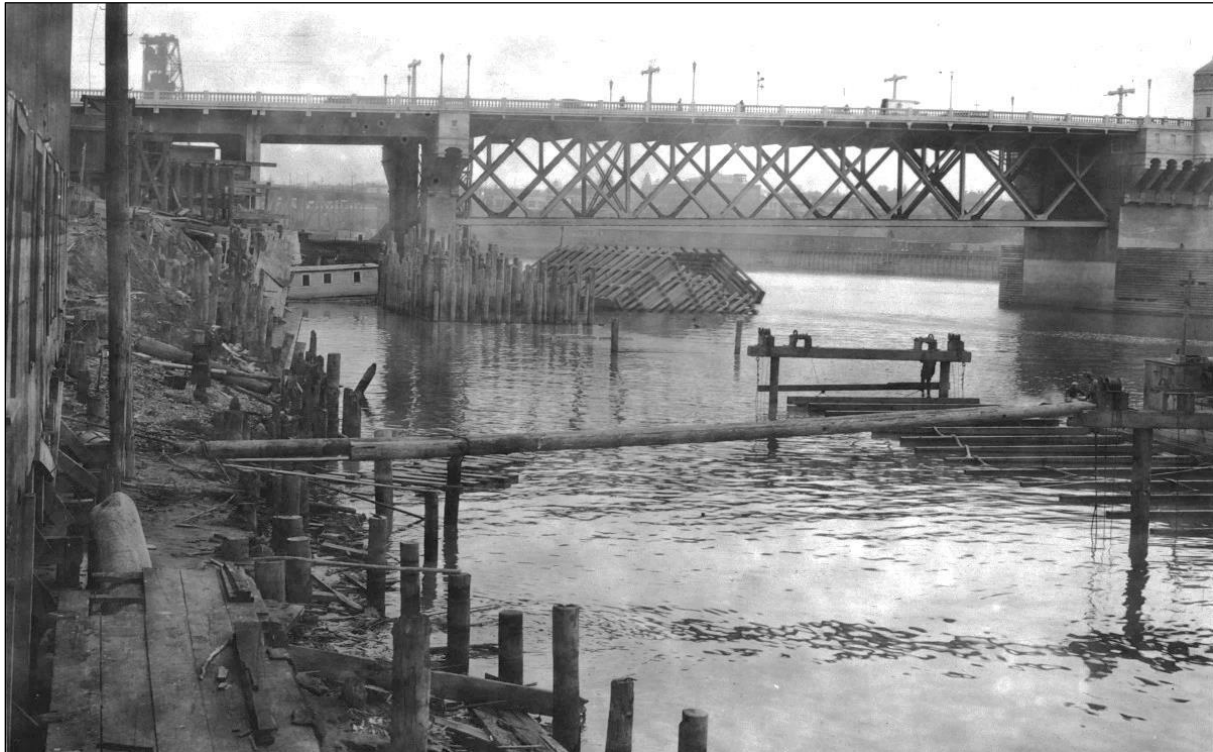
Figure 5-32. Dock remnants with continuing demolition in preparation of construction of the Harbor Wall, with the Burnside Bridge to the north. Photo dated March 8, 1928.

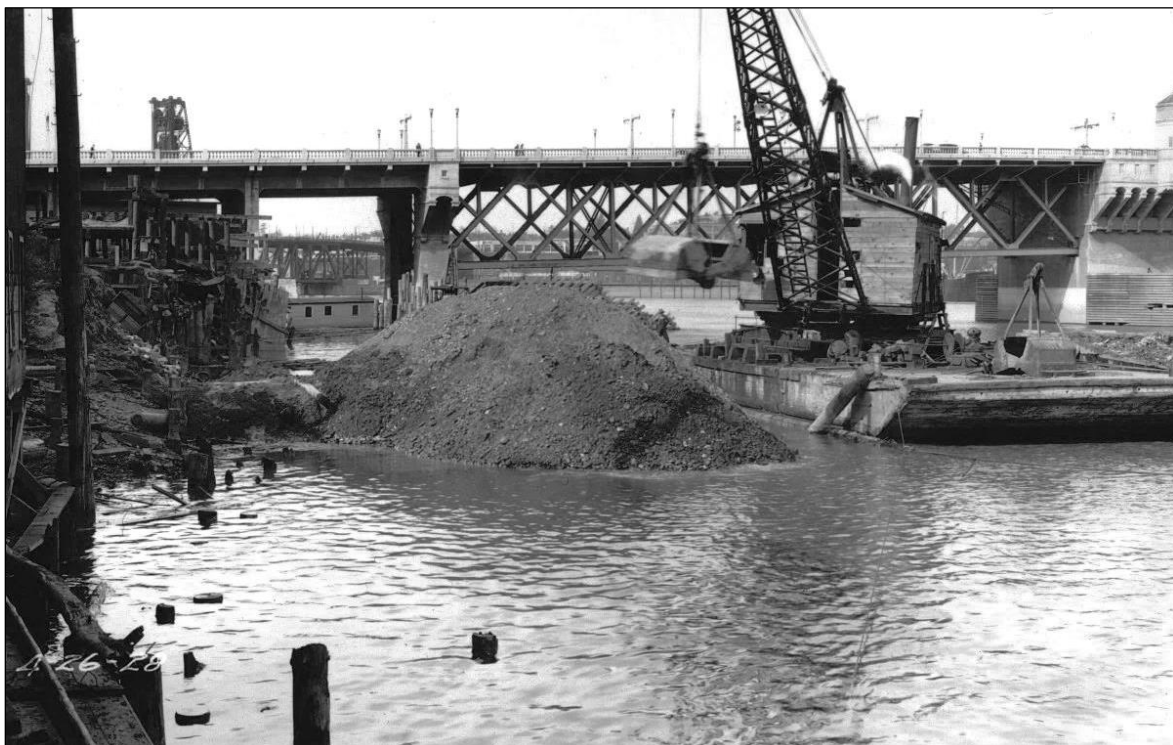
Figure 5-33. Stockpiling of dredged Harbor Wall fill immediately above the Burnside Bridge. Photo dated April 26, 1928.

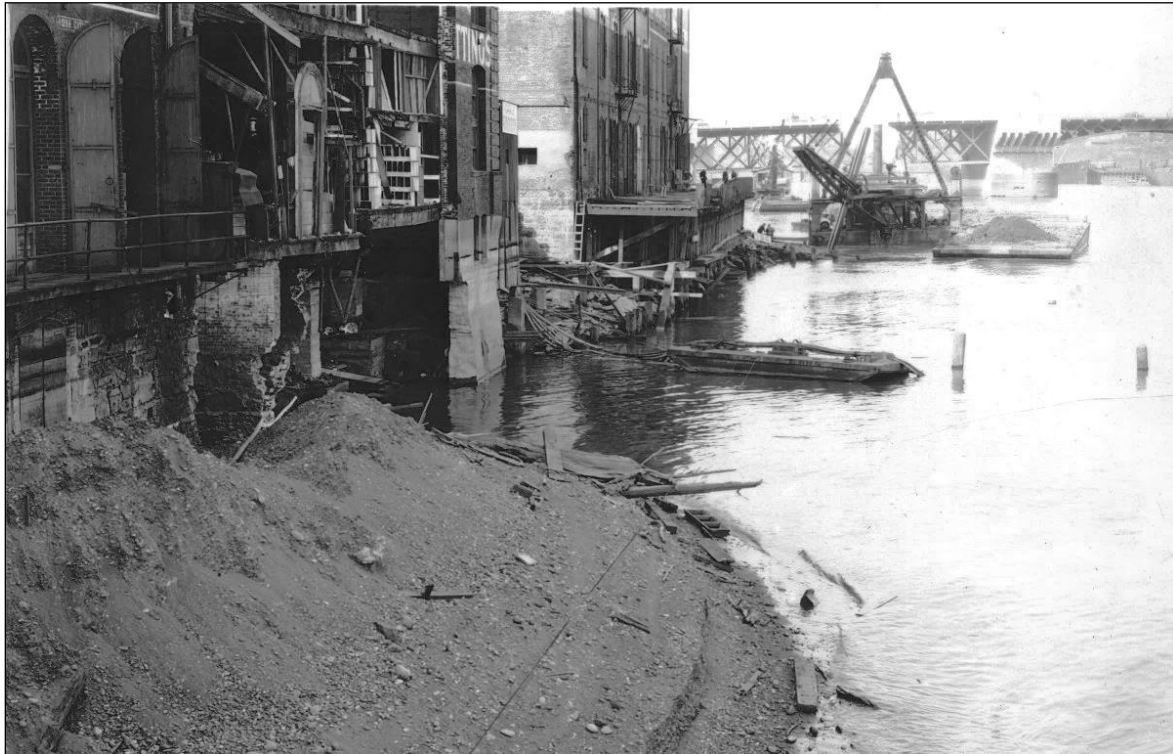
Figure 5-34. Dredging Harbor Wall fill, Burnside Bridge in the background. Photo dated April 26, 1928.

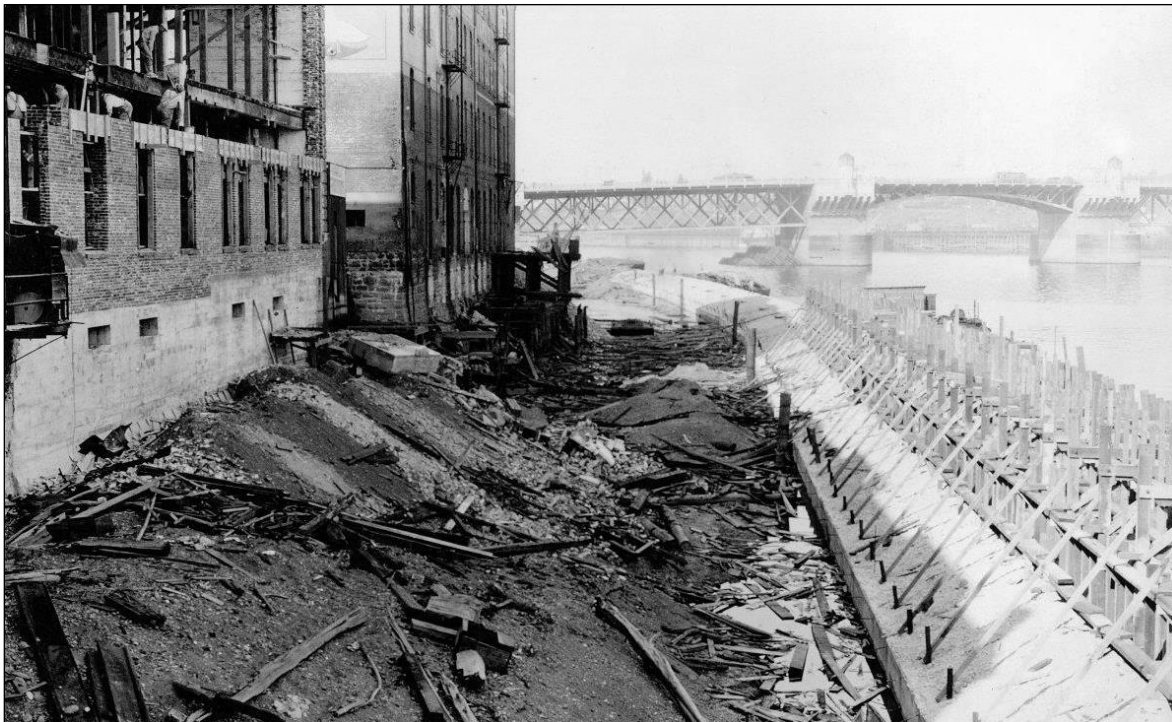
Figure 5-37. Construction in progress of Harbor Wall forms with view of debris on shoreline and reconstruction of rear wall of building damaged during dock removal on September 28, 1928.

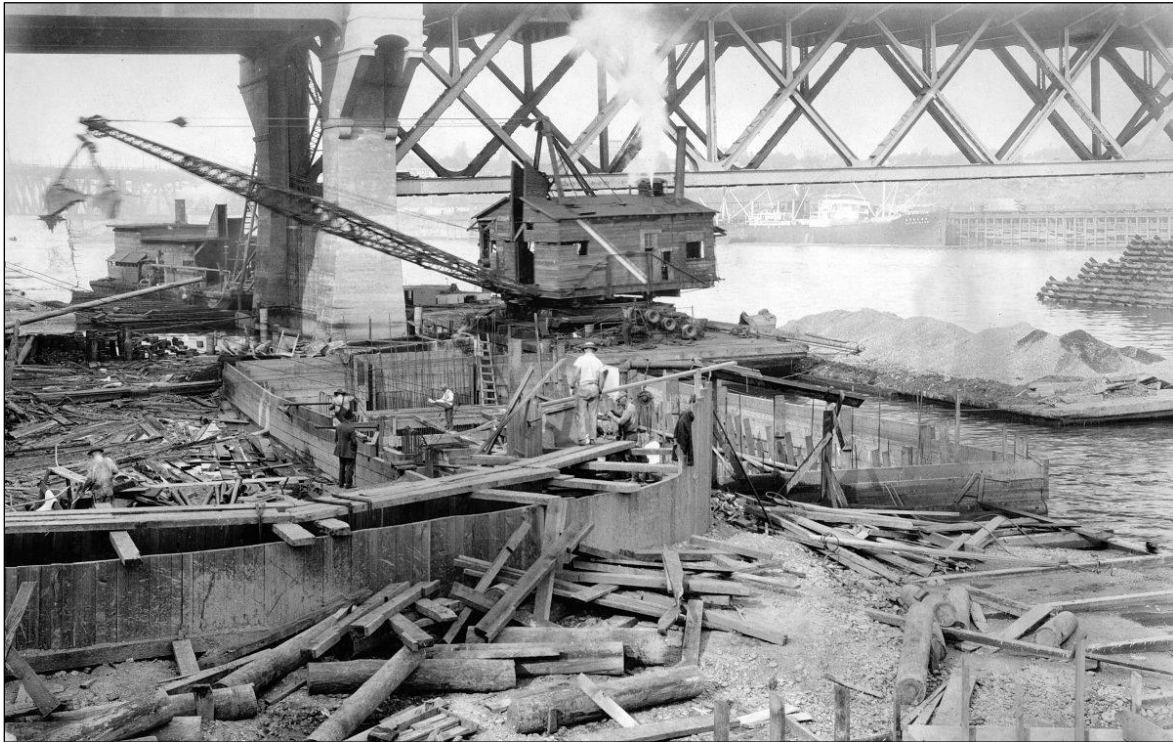
Figure 5-38. Construction of the foundations of the Ankeny Pumping Station. Current Burnside Bridge in background. Photo taken September 18, 1928.

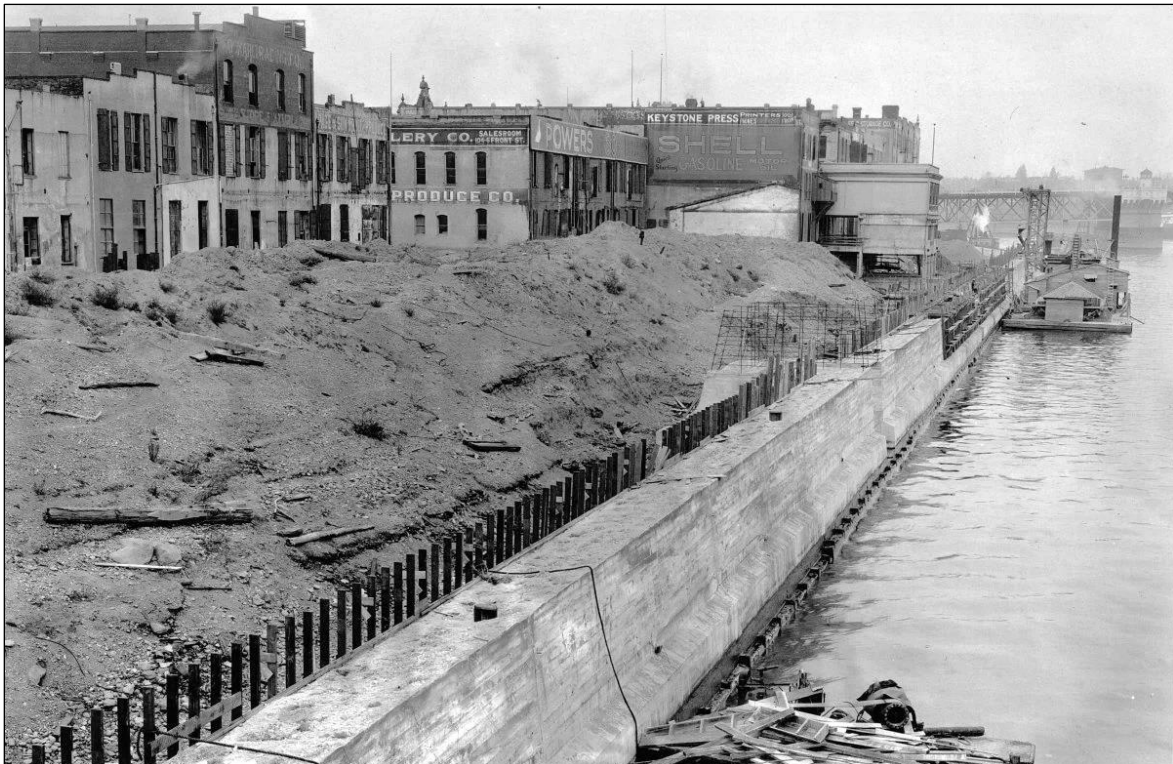
Figure 5-39. Construction of the Harbor Wall and surcharging of fill. Burnside Bridge is in the distance. Photo taken on October 16, 1928.

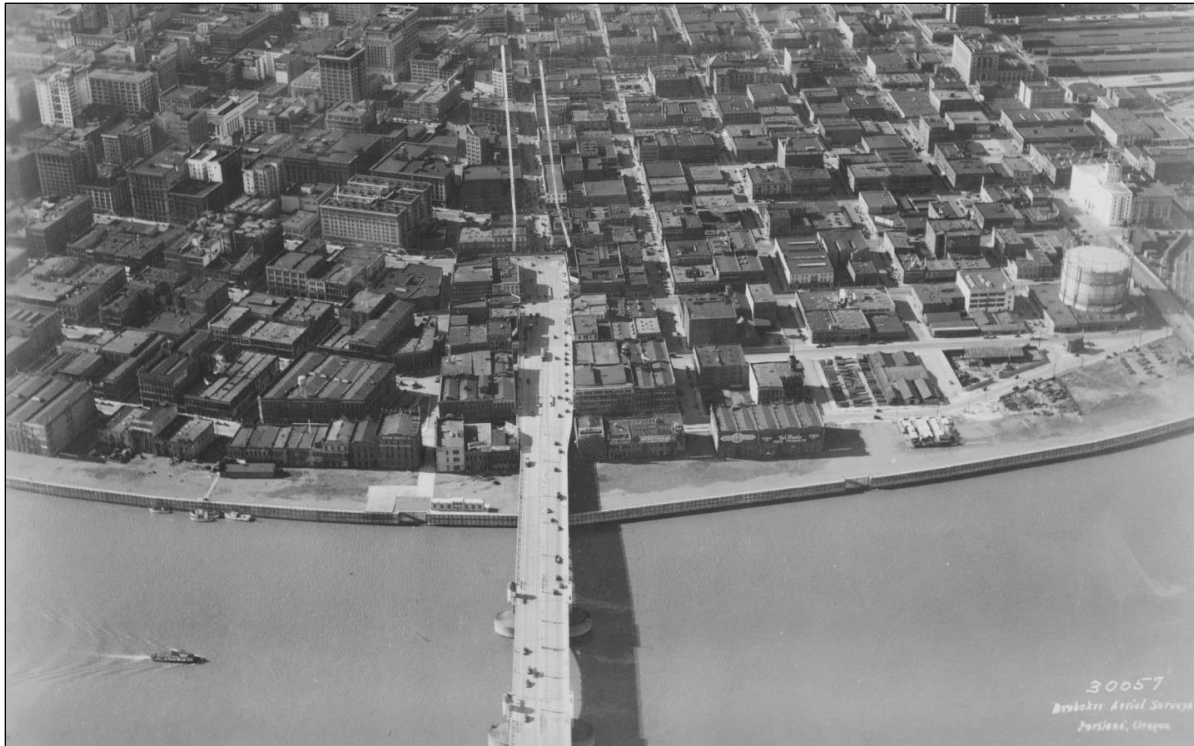
Figure 5-40. Aerial view of the completed Harbor Wall in 1930.

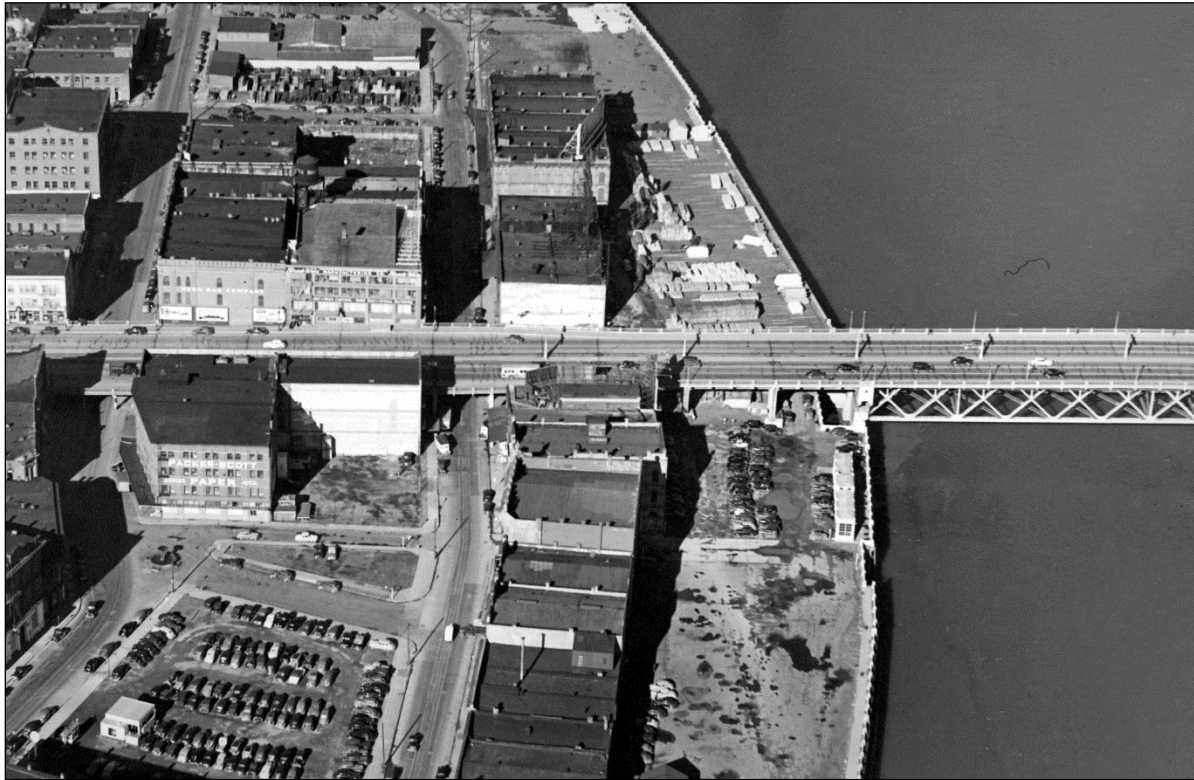
Figure 5-41. Aerial view of the Harbor Wall area around the western end of the Burnside Bridge in 1935. Note the Harbor Wall did not connect with the bridge pier.

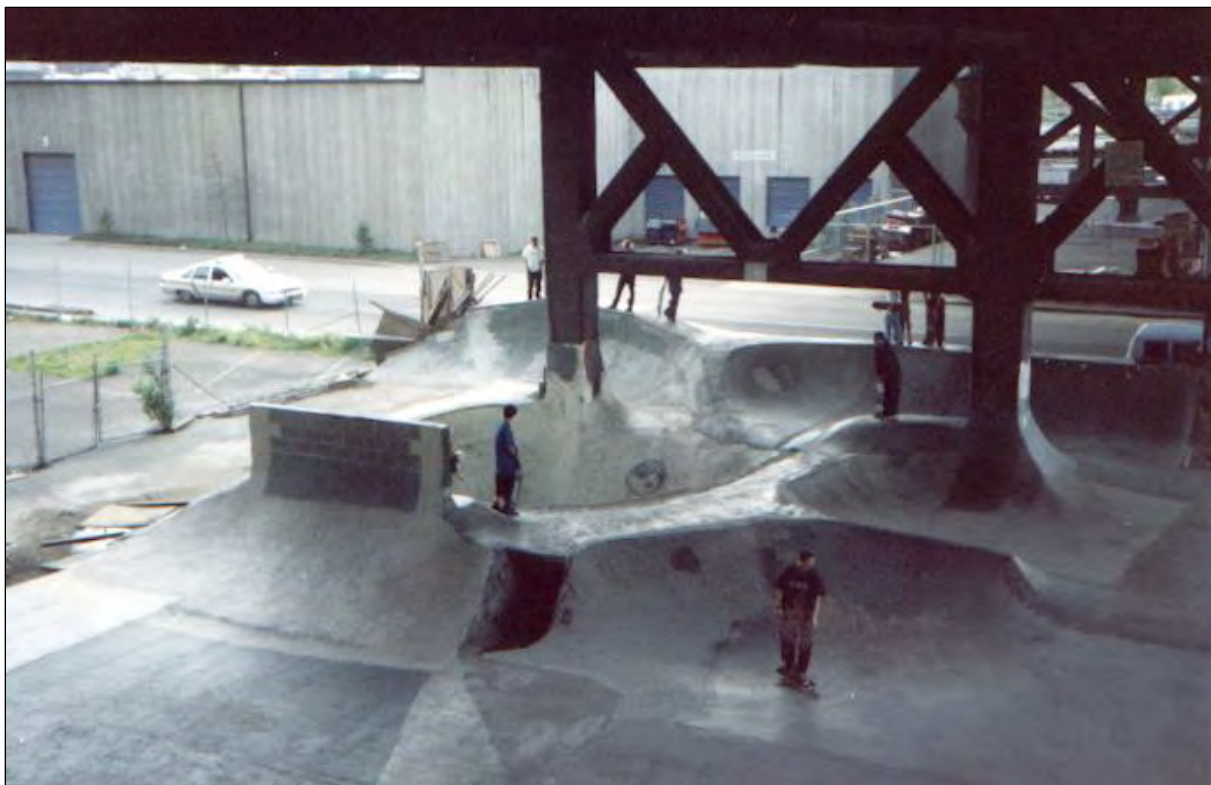
View: A view showing how the Burnside Bridge's columns have been incorporated into skating features. Looking southwest (Photo courtesy www.burnsideproject.org, used with permission).

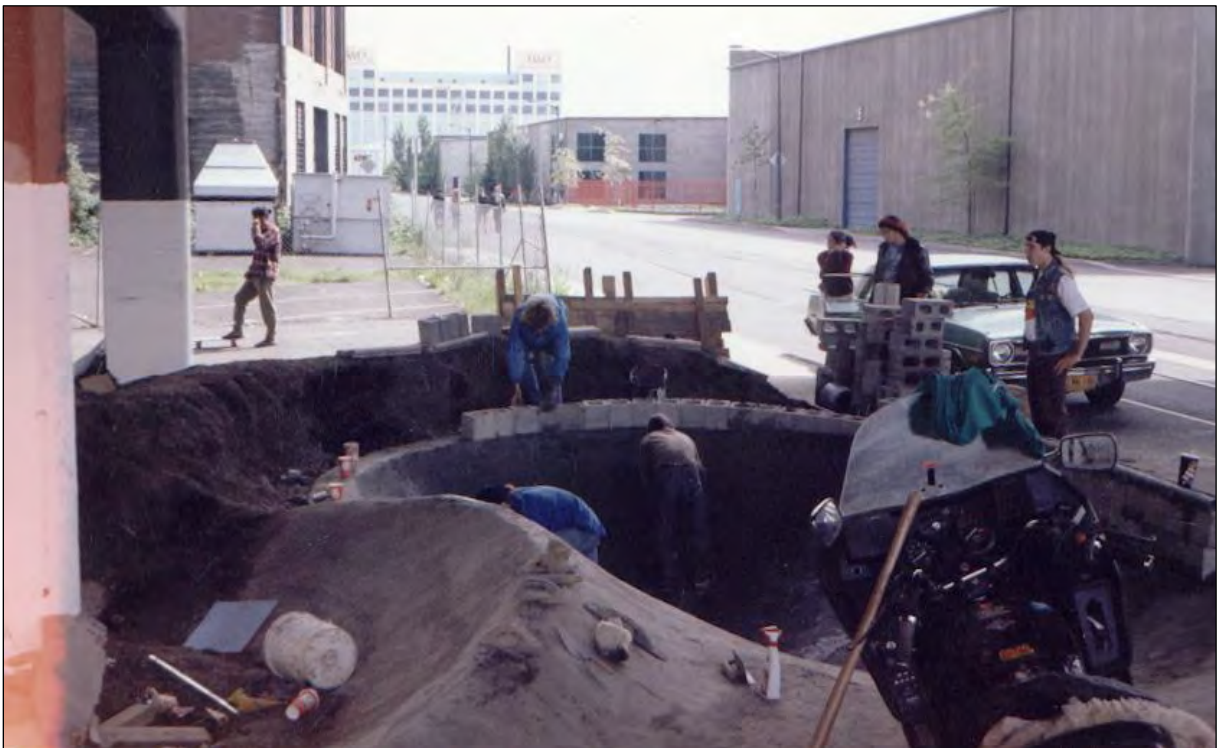
View: DIY construction at the Skatepark, circa 1990-1993. The view is towards the south. (Photo courtesy www.burnsideproject.org, used with permission).

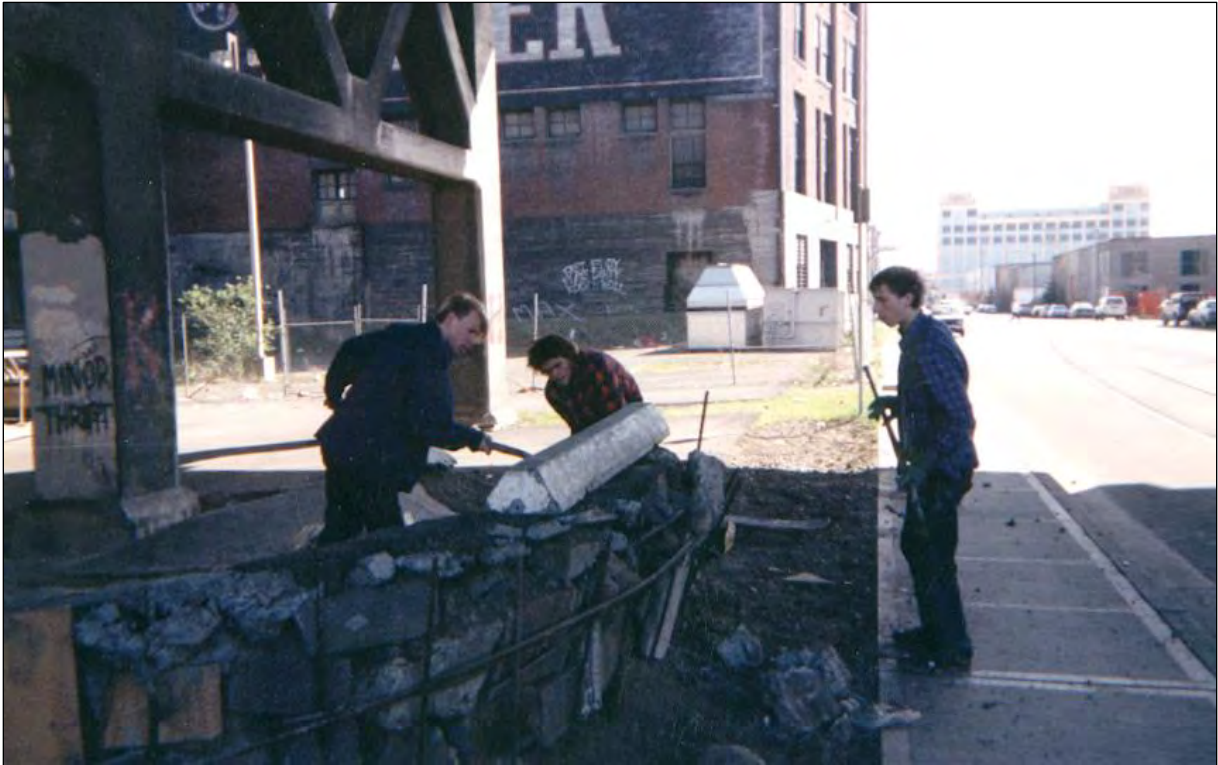
View: DIY construction at the Skatepark, dated to 1990-1993, The view is towards the south. (Photo courtesy www.burnsideproject.org, used with permission).

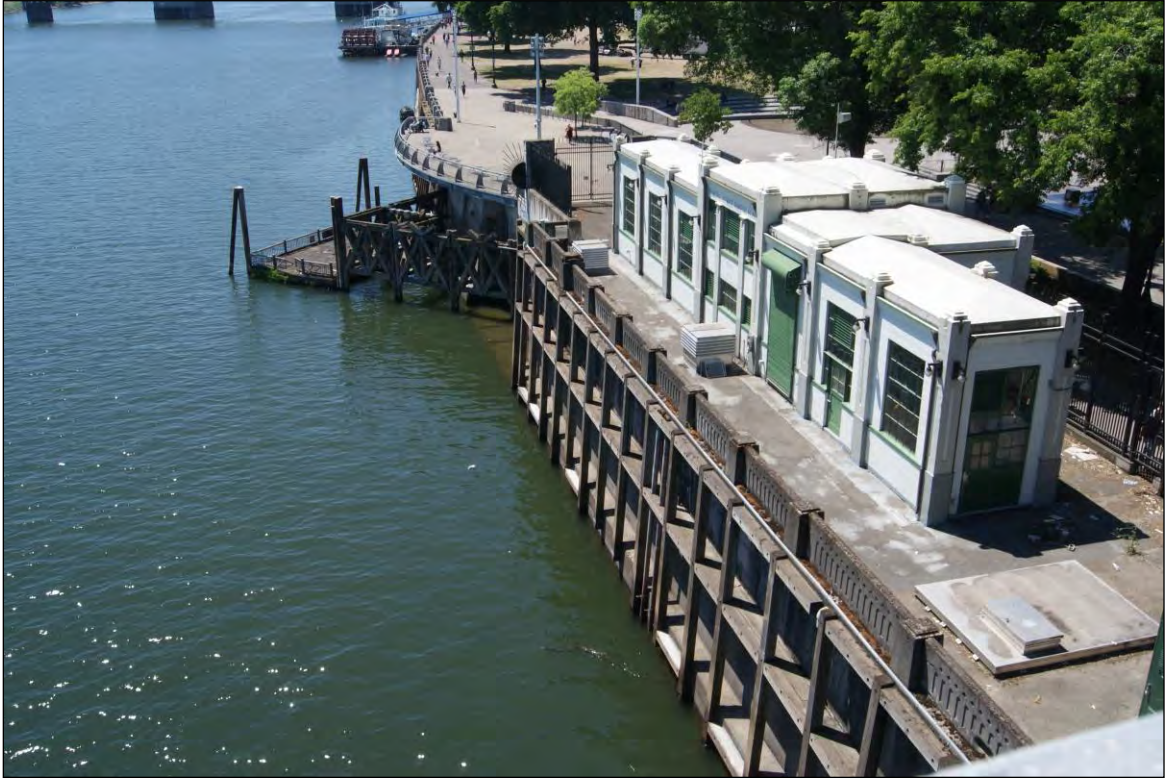
<p>A view of the Portland Harbor Wall and the Ankeny Pumping Station taken from the Burnside Bridge; the view is towards the southwest. Note the original concrete rail panels adjacent to the pumping station.</p>	
Preliminary National Register Findings: <input type="checkbox"/> National Register listed <input checked="" type="checkbox"/> Potentially Eligible: <input checked="" type="checkbox"/> Individually <input type="checkbox"/> As part of District <input type="checkbox"/> Not Eligible: <input type="checkbox"/> In current state <input type="checkbox"/> Irretrievable integrity loss <input type="checkbox"/> Lacks Distinction <input type="checkbox"/> Not 50 Years	
State Historic Preservation Office Comments: <input type="checkbox"/> Concur <input type="checkbox"/> Do Not Concur: <input type="checkbox"/> Potentially Eligible Individually <input type="checkbox"/> Potentially Eligible as part of District <input type="checkbox"/> Not Eligible

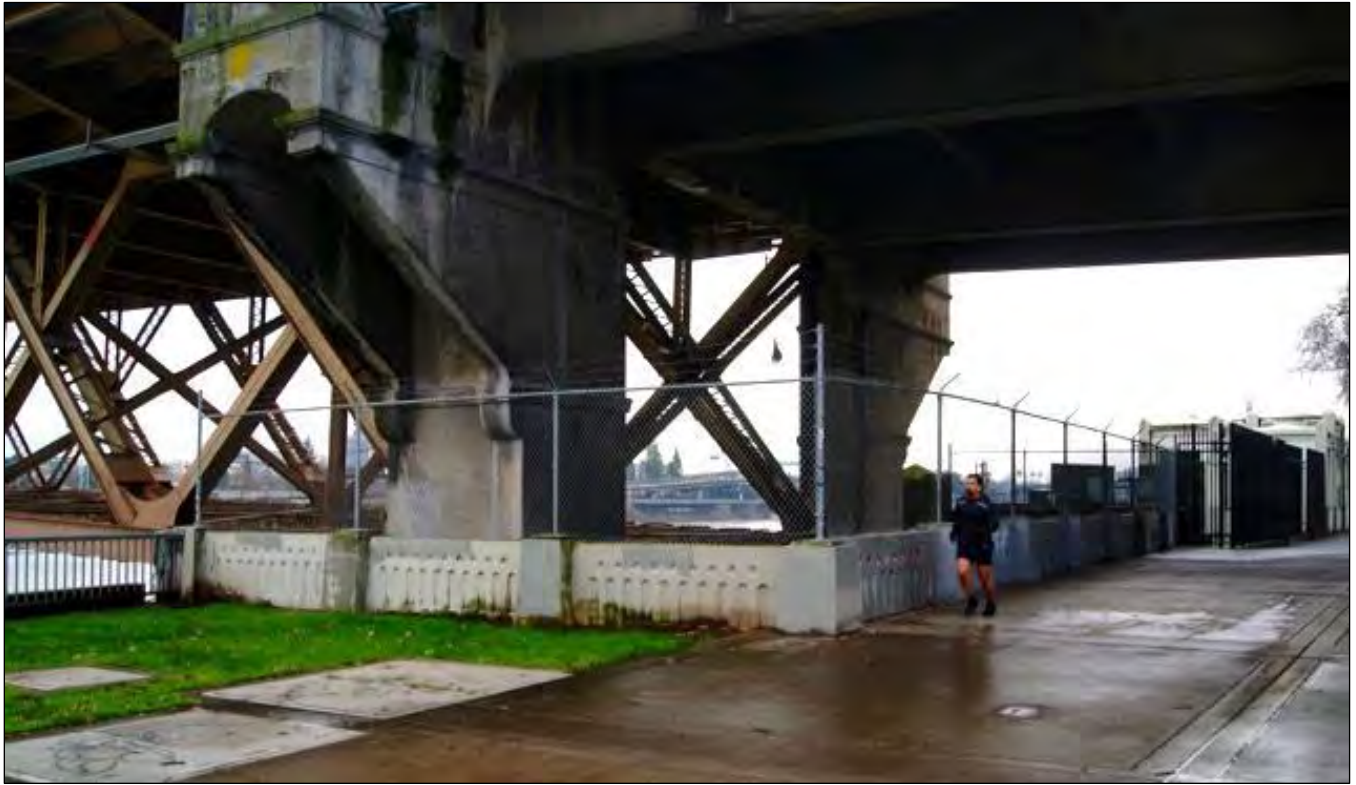
View: The Harbor Wall where it is built around Pier 1 of the Burnside Bridge, view facing southeast.

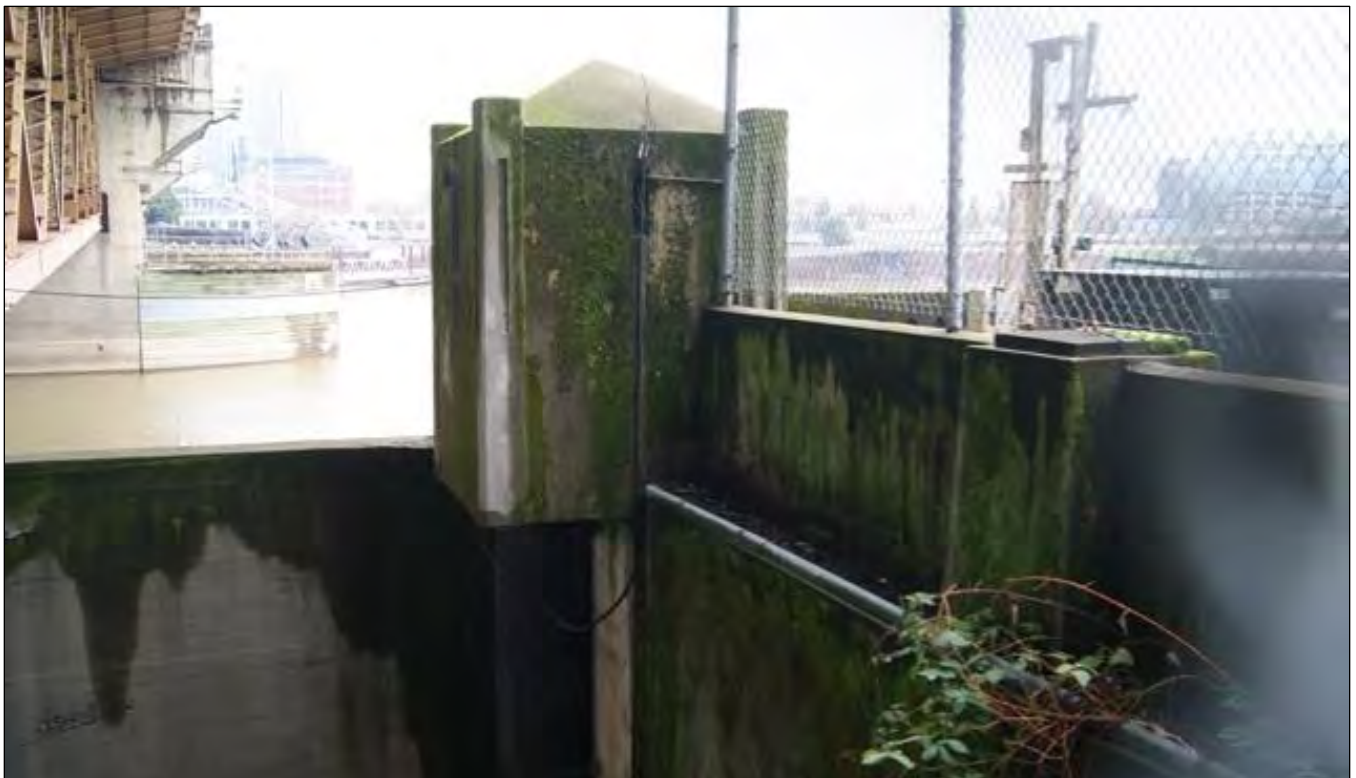
View: A small concrete structure built on the Harbor Wall south of Burnside Bridge's Pier 1, view to east.
